DELAWARE RIVER BASIN
INDIAN RUN, MONMOUTH COUNTY
NEW JERSEY

INDIAN LAKE DAM

NJ 00188

PHASE 1 INSPECTION REPORT NATIONAL DAM SAFETY PROGRAM

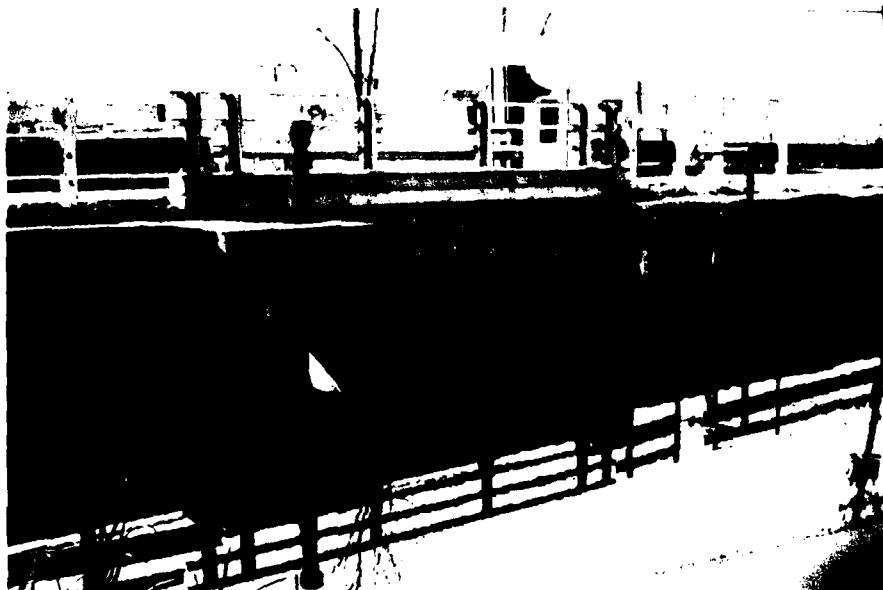
The spillway structure appeared to be structurally sound. Concrete surfaces were eroded with some spalling and exposed aggregate observed. The spalling was most pronounced near the crest.

PHOTO 1
SPILLWAY

- 1) The gaps adjacent to the bridge wingwalls should be suitably repaired and the embankment filled and stabilized.
- 2) The spillway structure and outlet works should be thoroughly inspected with the lake drawn down and then renovated as required.

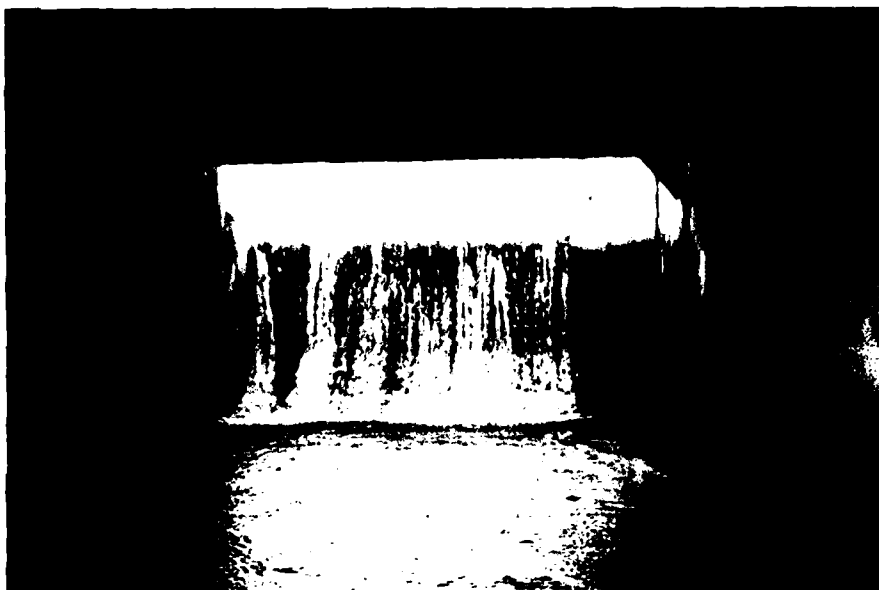
PHOTO 2
DOWNSTREAM FACE OF SPILLWAY AND DISCHARGE CHANNEL

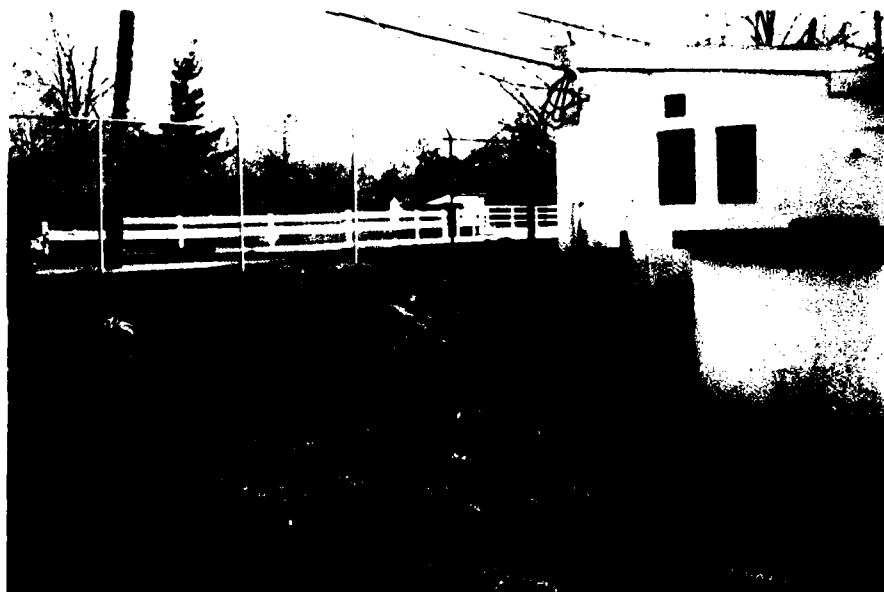
PHOTO 4

The crest of dam appeared to be level and uniform in width and the paved road was in good condition. The downstream face, north of the waterworks, was uniformly graded and covered with a uniform stand of grass. The downstream face, south of the waterworks, was covered with ground cover, weeds and small trees.

DOWNSTREAM FACE OF DAM

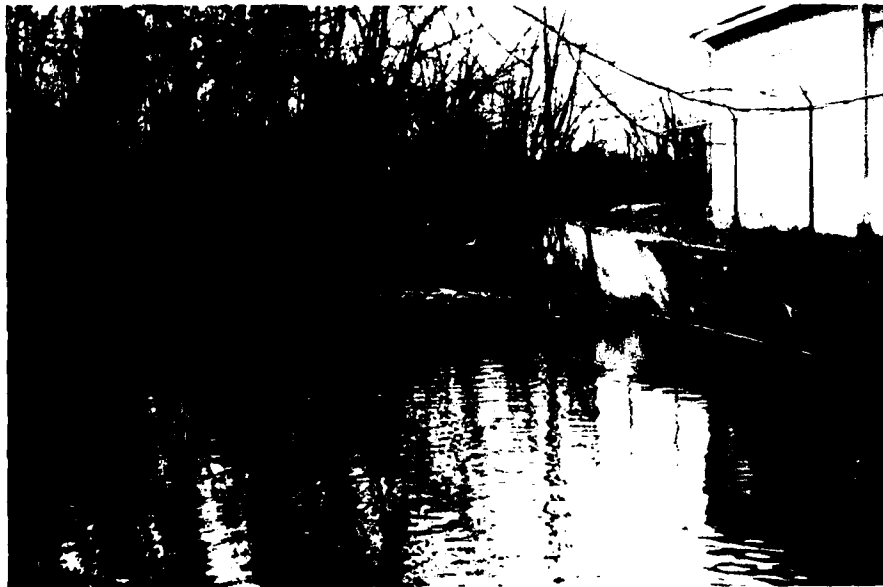
PHOTO 10

DOWNSTREAM CHANNEL
